Final Report FY97 Section 319 Grant Program

DEP Contract WM682: Lake Munson Restoration

Submitted by: Leon County Public Works
2280 Miccosukee Road
Tallahassee, FL 32308
850/488-8003

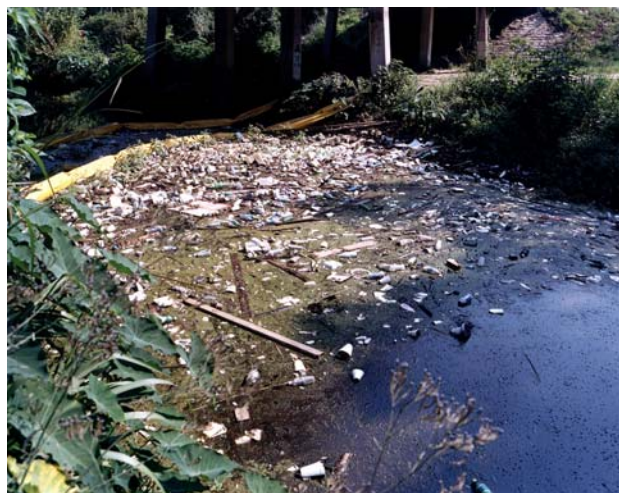
The delta at Lake Munson contained a tremendous quantity of floatables. A community "Lake Munson Clean-Up" held in September 2000 removed 24 tons of debris from the lake edge. In addition, the construction firm removed approximately 8 tons of debris captured in sediment barriers across the slough during the project, as seen in the adjacent photo.

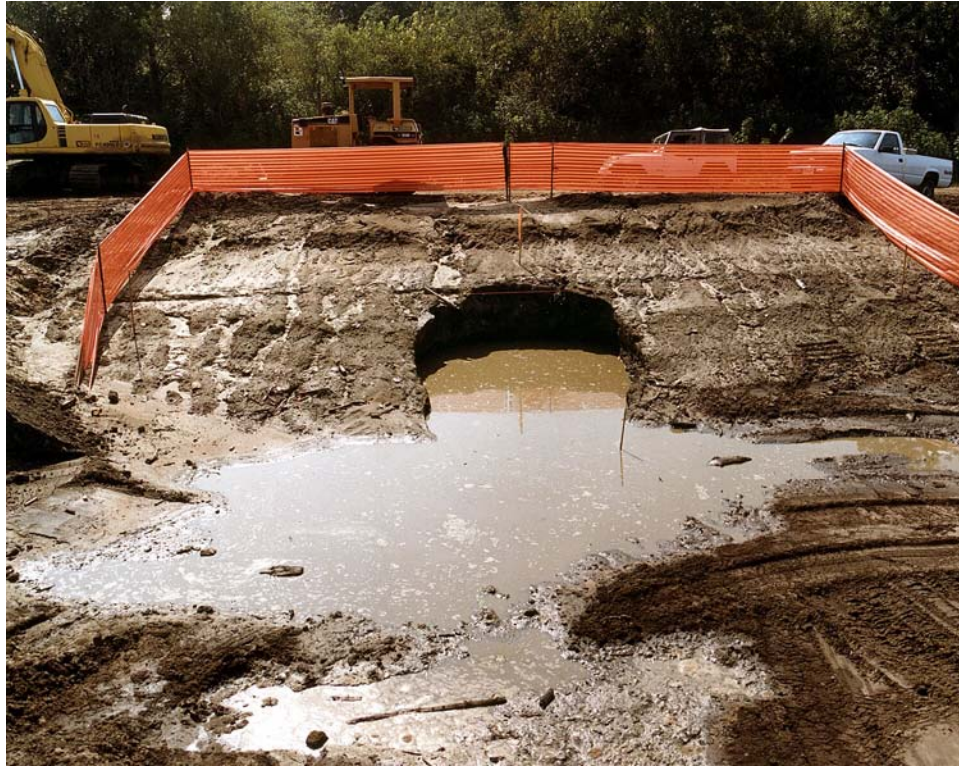
A small karst feature developed in the east pond embankment after Lake Henrietta experienced a high water level in August 2000. The extent of the cavity could not be readily determined by the geotechnical firm. Since stabilization with fill material was not a viable corrective action, the throat was capped with a concrete slab, supported on concrete pilings set in the bedrock below the cavity. The perimeter of the concrete slab was turned down into the weathered limestone overlying the cavity to prevent seepage from further eroding the confining layer.

Ground-penetrating radar (GPR) was used along the embankment length to evaluate the possibility of additional karst features in the project area. An area roughly 100 feet south of the failure was identified as a potential concern in the future. The GPR also revealed areas of concern in the vicinity of the proposed diversion structures and bridges. Soil borings confirmed the presence of voids at the proposed piling locations. The piling locations were adjusted and the construction method was changed to auger-cast pilings rather than driven piles, to reduce potential collapse of the subgrade. Also, the sheet piling was vibrated into the surface sands rather than driven. The increased construction costs at the diversion structures were approximately \$62,000.

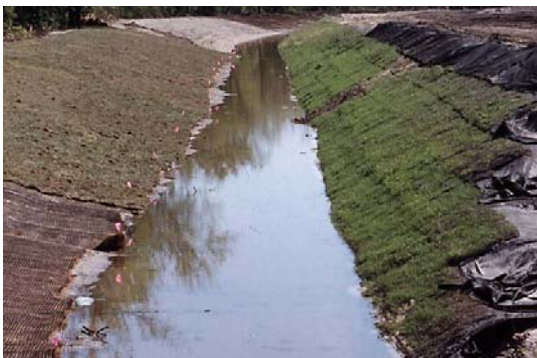
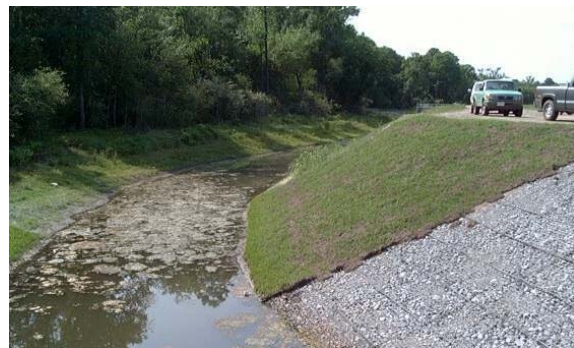
The view on the left (above) shows the soil lifts and Mirafi Geogrid which wrapped the lifts. The right photo shows the area at final project acceptance, with gabion baskets adjacent to the flow diversion structure into Lake Henrietta.

Improvements to Munson Slough included realignment, regrading and stabilization of channel banks for erosion control between Springhill Road (including the slough adjacent to Lake Henrietta) and Lake Munson. Stormwater flows were evaluated with a basin-wide model to determine peak flow rates and timing. The information was crucial in determining the appropriate measures to reduce scour and deposition throughout the length from Springhill Road to Lake Munson. Limited change to the channel alignment was needed to achieve velocities acceptable for grassed channels, allowing the slough to retain a natural meander along its length from Lake Henrietta to Lake Munson. The velocity also determined which areas required geotextile stabilization and which areas could be addressed by regrading the banks to a 5:1 (H:V) slope. The berm for Lake Henrietta separating the slough from the facility was stabilized with Mirafi geogrid lifts to ensure the berm would resist peak flow scour velocities.

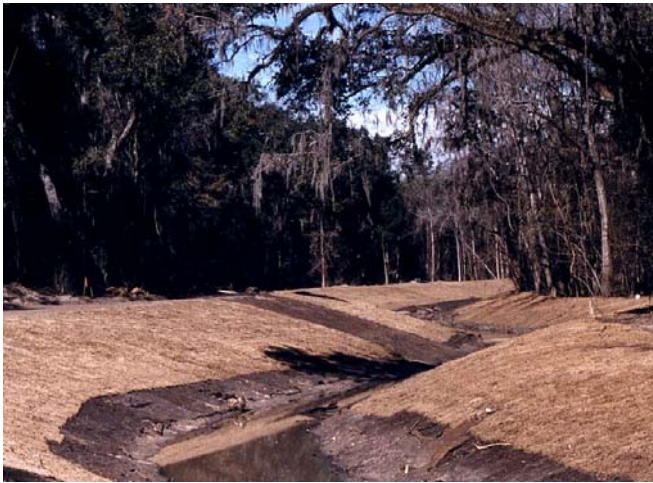
The geotextile materials specified for the slough banks were intended to withstand the anticipated peak velocities during saturated conditions, assuming two years of normal flow conditions following the construction. The slough meander was incorporated into the design as shown in the photo to the left. Although the construction began during record drought conditions, three named storms (TS Helene in September 2000, TS Allison in June 2001, TS Barry in August 2001) and an unnamed winter storm (March 2002) exceeded the 100-year rainfall intensity at the project site

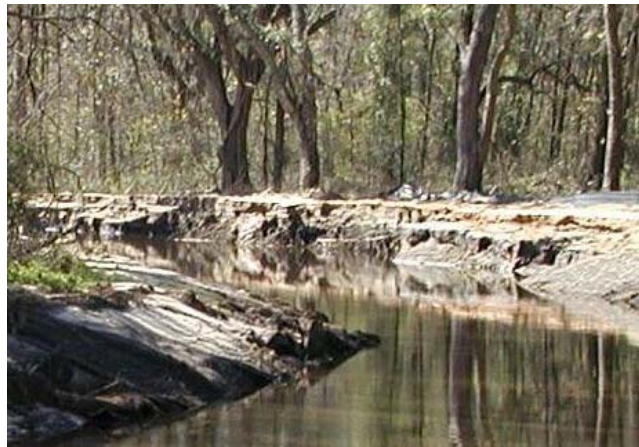
during the project period. The photograph below shows the effects of the March 2002 storm on the slough south of Capital Circle.

The final access road configuration balances the environmental concerns and the funds remaining at the end of the project. In order to avoid the expense and time required to rebuild the slough banks the third time, the road width south of Capital Circle was reduced in order to complete the project before the 2002 storm season. (The estimated costs to reconstruct the affected areas with a hardened surface

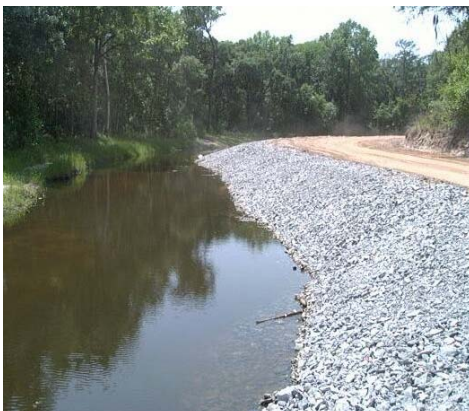
exceeded \$750,000.) The photograph to the left shows how the slough banks were regraded to correct the vertical erosion. Areas which were most affected by the scour were reinforced with gabion rock and basket material. The access road was reconstructed as a single lane in the locations where the maintenance activity could be accommodated in some other manner, such as truck turn arounds or short distance backing maneuvers.

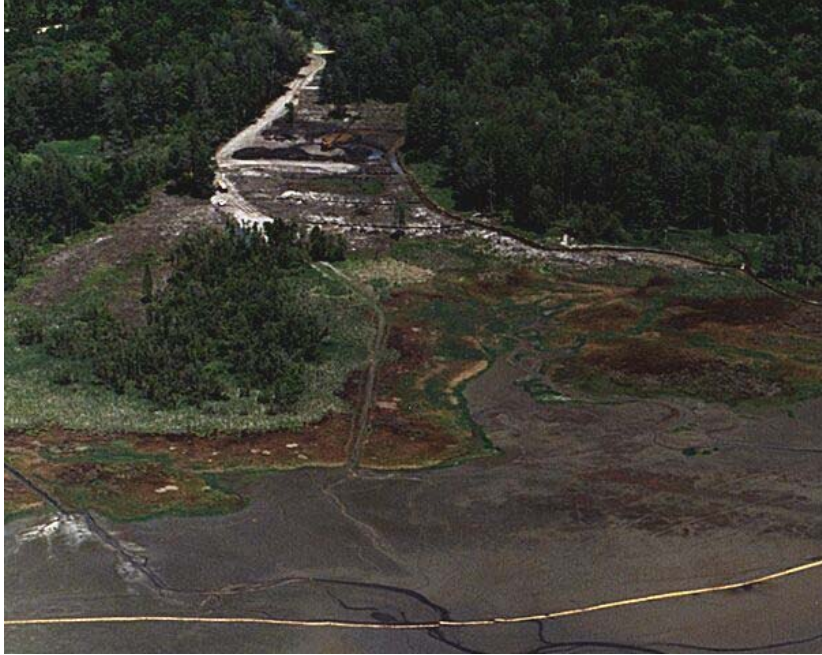
The “delta” formed at the confluence of Munson Slough and Lake Munson, encompassing an area of approximately 29 acres. The “delta” was excavated to restore the channel inflow to a more natural state while removing trash and debris from the lake. The trash included stoves, refrigerators, tires, and

automotive parts which were taken to the Solid Waste Facility. The significant amount of tree debris in the upper reaches of the delta were taken to the Eisenhower site. The northernmost portion of the delta was estimated to contain 12 percent trash and 7 percent tree debris by volume. An amphibious vehicle was used by the land surveyor and geotechnical firm to access the delta for soil borings and topographic survey. The soils were determined to be primarily very soft organic plastic silts. The extent of the cypress fringe was surveyed, and a setback of 15 feet was included in the design to reduce construction impacts to the trees.

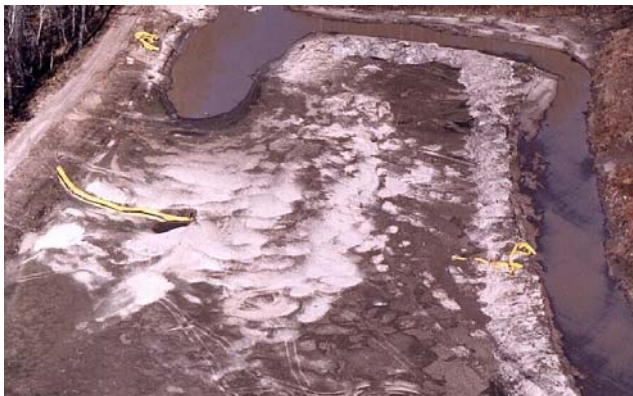
Helene in September 2000 required a second excavation of deposited material. The adjacent photograph shows some of the sediment at the transition between the slough and Lake Munson. The third excavation following the back-to-back tropical storms Allison and Barry in the summer of 2001 included an extra “sump” depth as a precaution. The unnamed winter storm of March 2002 again damaged the slough and deposited material in the delta vicinity. The lake bottom was surveyed and determined to be substantially in compliance with the original design, so no further excavation was performed.
